# Quarterly Bulletin

Volume 76  
Number 3  
September 2021

# NEW EVIDENCE FOR THE COROTOMAN RE-USE HYPOTHESIS FOR THE STONE FLOOR OF COLONIAL CHRIST CHURCH, IRVINGTON, VIRGINIA<sup>1</sup>

By Marcus M. Key, Jr., Ph.D., Samuel T. Arnold, and Robert J. Teagle

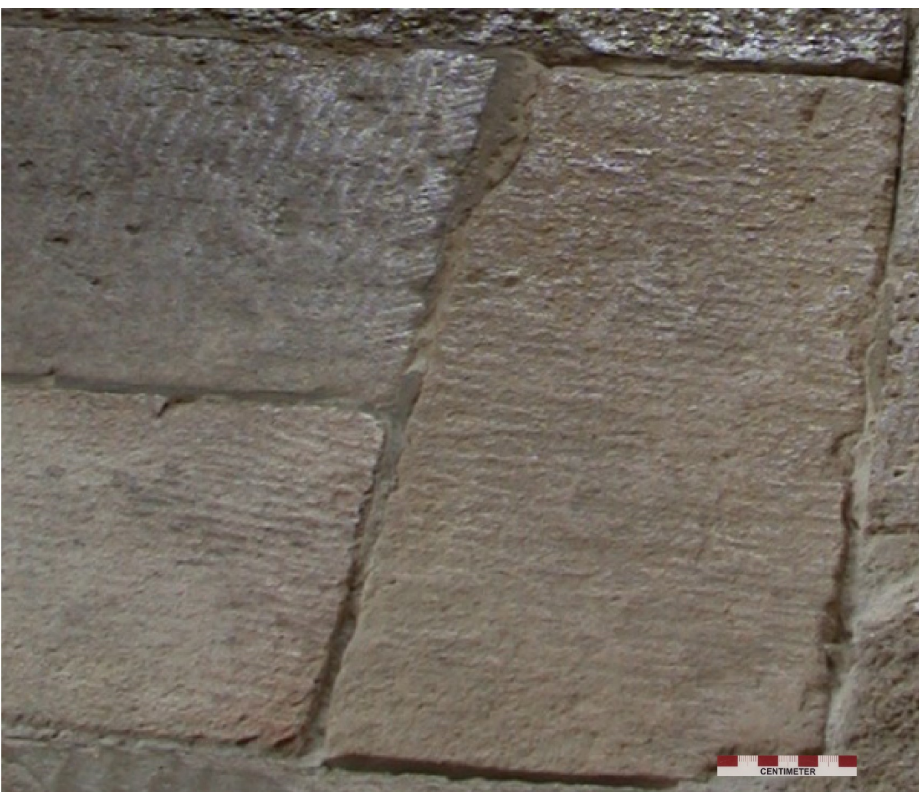
**Figure 2. Parallel tool marks on the surface of Purbeck Stone pavers from the floor of the nave of Christ Church.**

To reduce transportation weight and cost, the hand-dressed Purbeck Stone pavers were probably dressed at the quarry in or near Swanage, England (Key et al. 2010). Purbeck Stone pavers typically have a pattern of tool marks on the flattened upper face. The traditional finish for Purbeck Stone pavers in England is a pattern of parallel continuous furrows called a batted or tooled finish (Benfield 1940; Natural Stone Institute 2016). This is commonly seen in the Purbeck Stone pavers in the town of Swanage, England where they were quarried (Key et al. 2010) and in the streets of nearby Corfe Castle. One can also see this in Christ Church (Key et al. 2010:fig. 2). The flatter the original bedding plane of the Purbeck limestone, the shallower the chisel marks and the less noticeable the pattern is. In some pavers, this pattern is preserved; in others it has worn away (Figure 2). If the stone pavers from Corotoman were reused in Christ Church, the tool marks should have similar spacing. To that end, we measured the spacing of tool marks to the nearest 1 mm using digital calipers.

We found two Purbeck Stone pavers in the artifact collection from Hudgins’ 1978 excavation of Corotoman that had tool marks. We measured three pavers in the floor at Christ Church that had well preserved tool marks. Due to the removal of stone pavers from Corotoman that were in good shape for reuse in Christ Church, there were fewer places on which to measure tool mark spacing (n = 15) compared to Christ Church (n = 52). Despite this, the spacing was not significantly different between the Purbeck Stone pavers from Corotoman (mean = 11.9 mm) and those from Christ Church (mean = 12.5 mm) (Figure 5; t-Test, P = 0.449). This supports the Corotoman re-use hypothesis for the Purbeck Stone pavers in Christ Church.

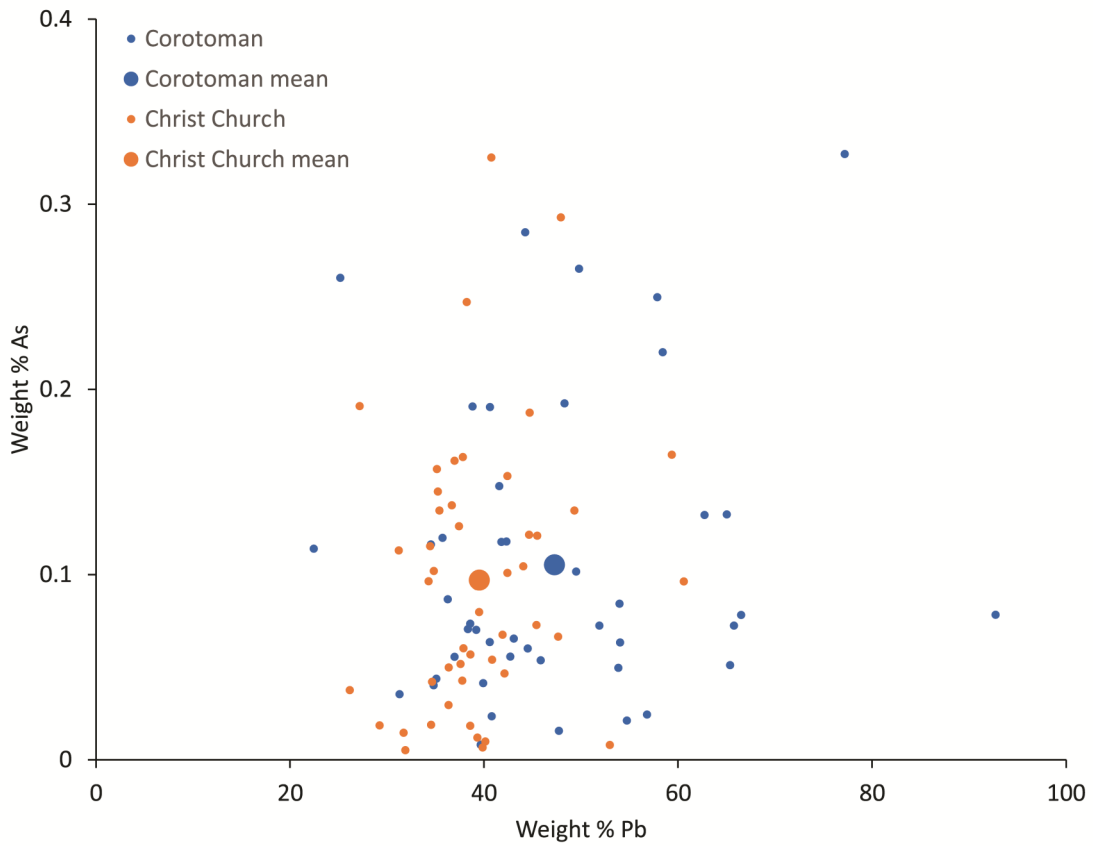
**Figure 3. Plot of weight % Lead (Pb) versus Arsenic (As) in lead samples showing similar results from Corotoman and Christ Church.**

The mean Pb/As ratio was not significantly different between the lead samples from Corotoman and Christ Church (Table 2, Figure 3, t-Test,  $P = 0.331$ ). Nor was the Ca/Mg ratio significantly different between the Purbeck samples from Corotoman and Christ Church (Table 2, Figure 4, t-Test,  $P = 0.602$ ). Even if we

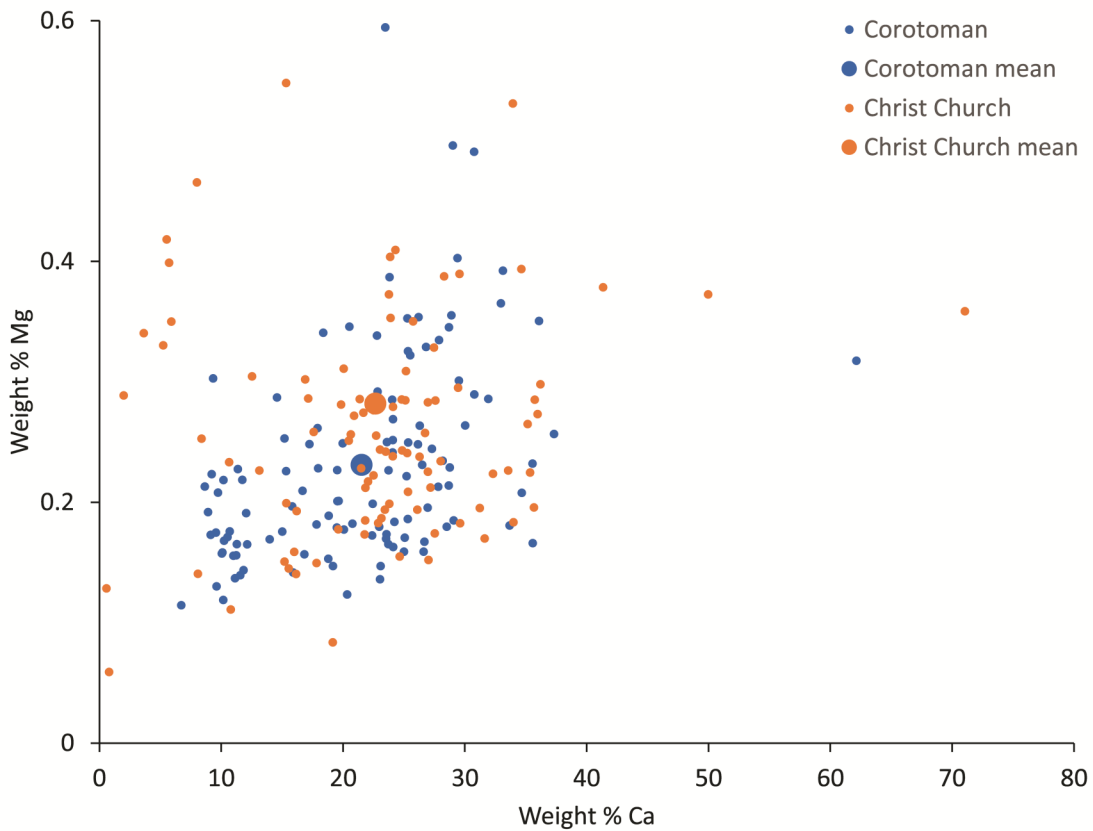
**Figure 4. Plot of weight % Calcium (Ca) versus Magnesium (Mg) in Purbeck samples showing similar results from Corotoman and Christ Church.**

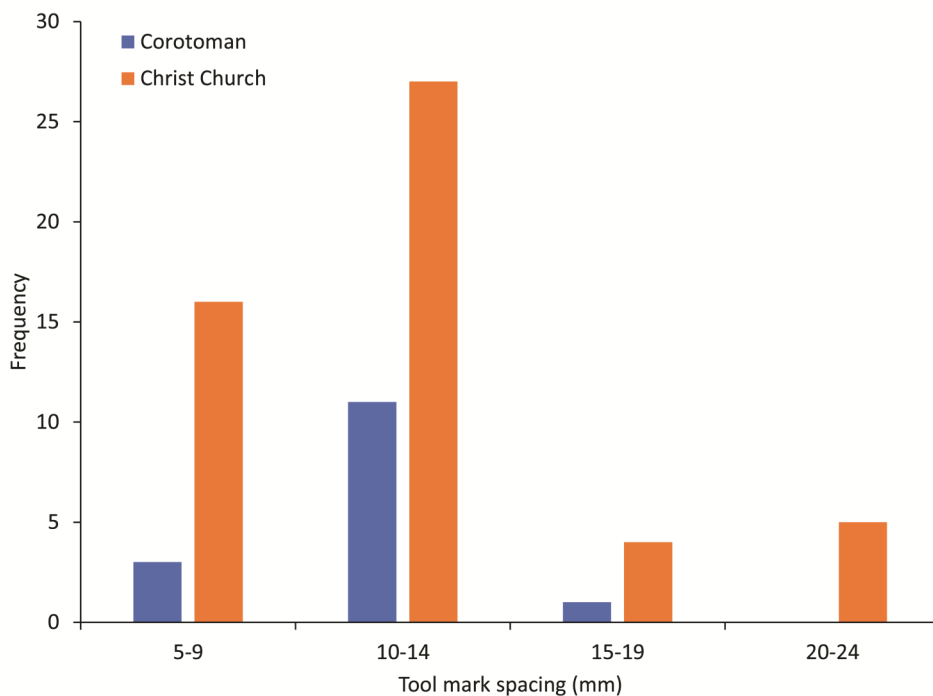
**Figure 5. Frequency histogram of tool mark spacing on stone pavers showing similar results from Corotoman (mean: 11.9 mm) and Christ Church (mean: 12.5 mm).**
